MSV Steam Bypass Upgrade Extends Valve Life

Improved design addresses excess erosion patterns

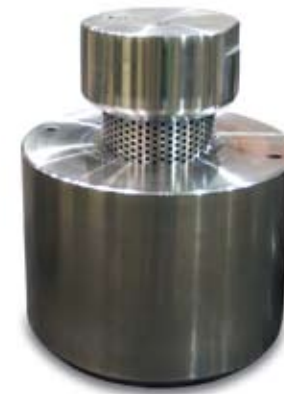
A close-up of the multi-hole configuration of the bypass valve head assembly.

The multi-hole bypass valve is an improved design that redirects steam through the bypass valve without excessive erosion to valve components, as is typically experienced with the original design. The redesigned bypass valve is a hollow steel cylinder with numerous holes that enable bypass steam to flow with no mechanical redirection necessary. The steam turbine's main stop valve performance remains unaffected by this upgrade.

"Another challenge for some operators is poor steam quality and the presence of solid particle erosion (SPE) within the steam turbine, which impacts the service life of the bypass valve," Bauer said. "Our multi-hole configuration is a totally different design that has no bypass head in the steam path, so no component is prone to failure from SPE.

"The valve's improved design enables even wear across the valve and increased life expectancy. The valve can be rotated in 90 degree increments, which can result in four times the wear compared to conventional designs," he added.

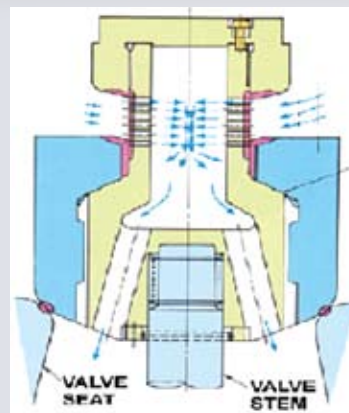
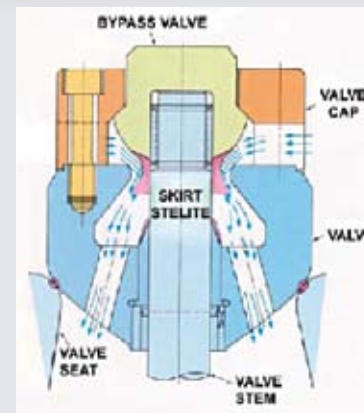
REGENCO's multi-hole steam bypass valve (left) eliminates the in-stream bypass valve from the original design (right), thus greatly reducing erosion within the assembly.

Under the original design, bypass valves and stop valve stems exhibit severe erosion in the area adjacent to the bypass valve. OEM attempts to eliminate this problem have included stem inlays and skirted bypass valves, as well as steam chest modifications. Erosion, and the subsequent need to replace valve stems, has significantly reduced time between outages.
